ASH GROVE CEMENT COMPANY

November 23, 1998

Re: Navajo Sandstone Reclamation, Your letter Dated October 28, 1998;
Refer to 3800, (U-010), UTU-070569

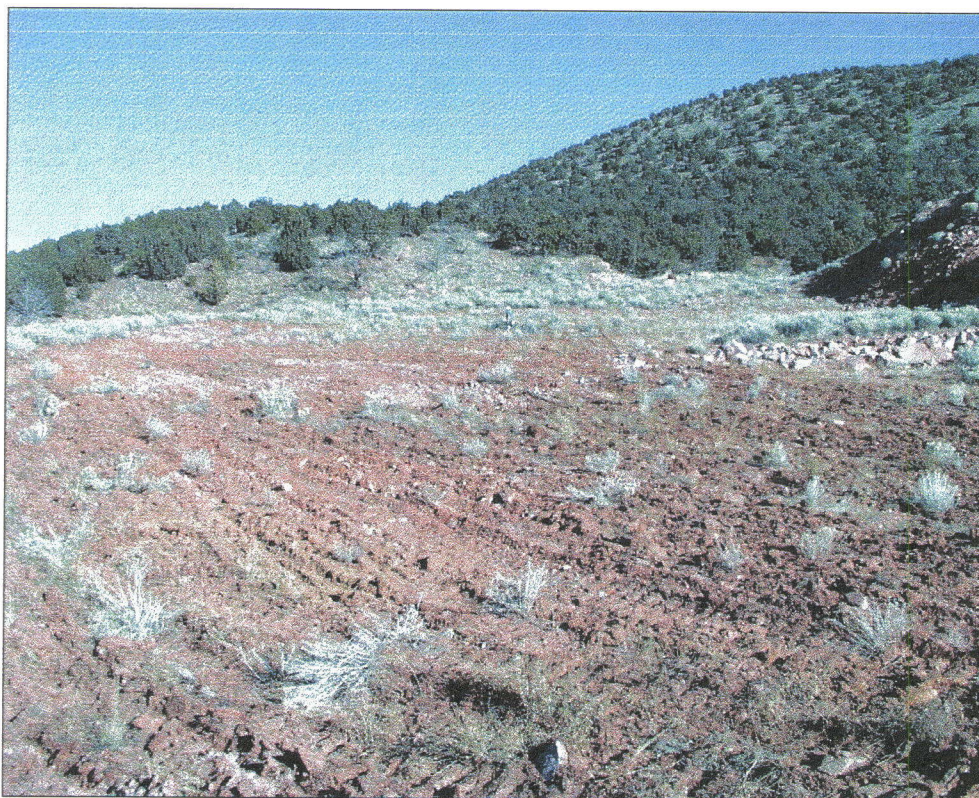
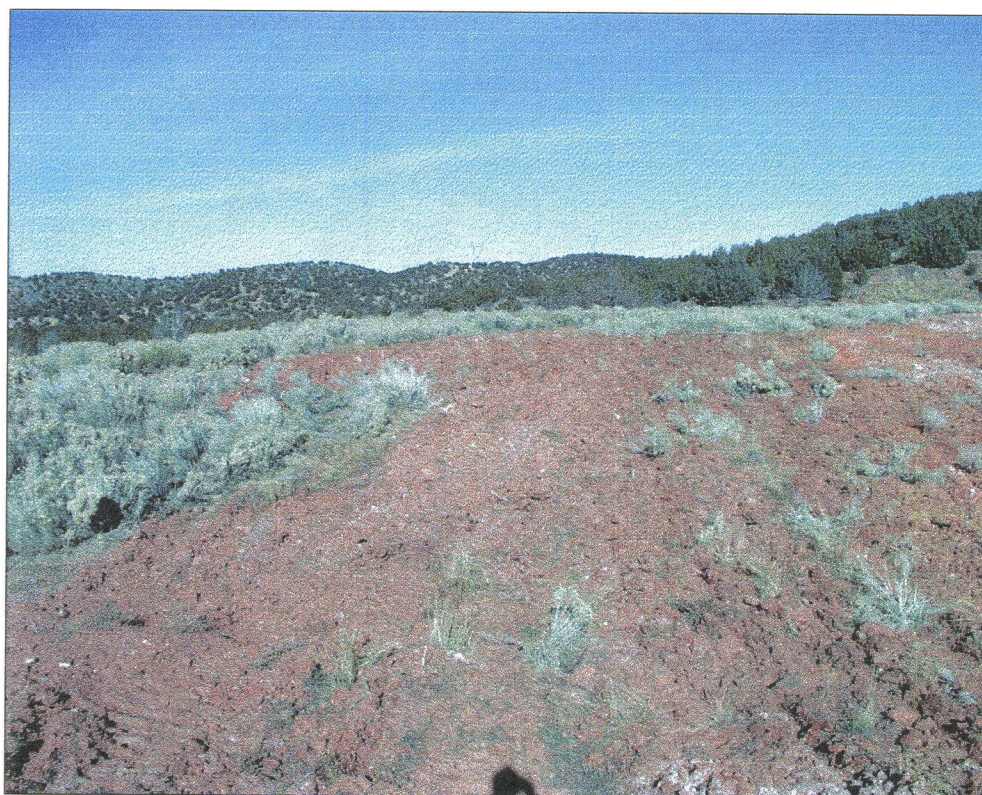
Pictures 1&2: Looking in a Northerly direction at the base of the quarry mountain. Note the areas ripped and seeded.

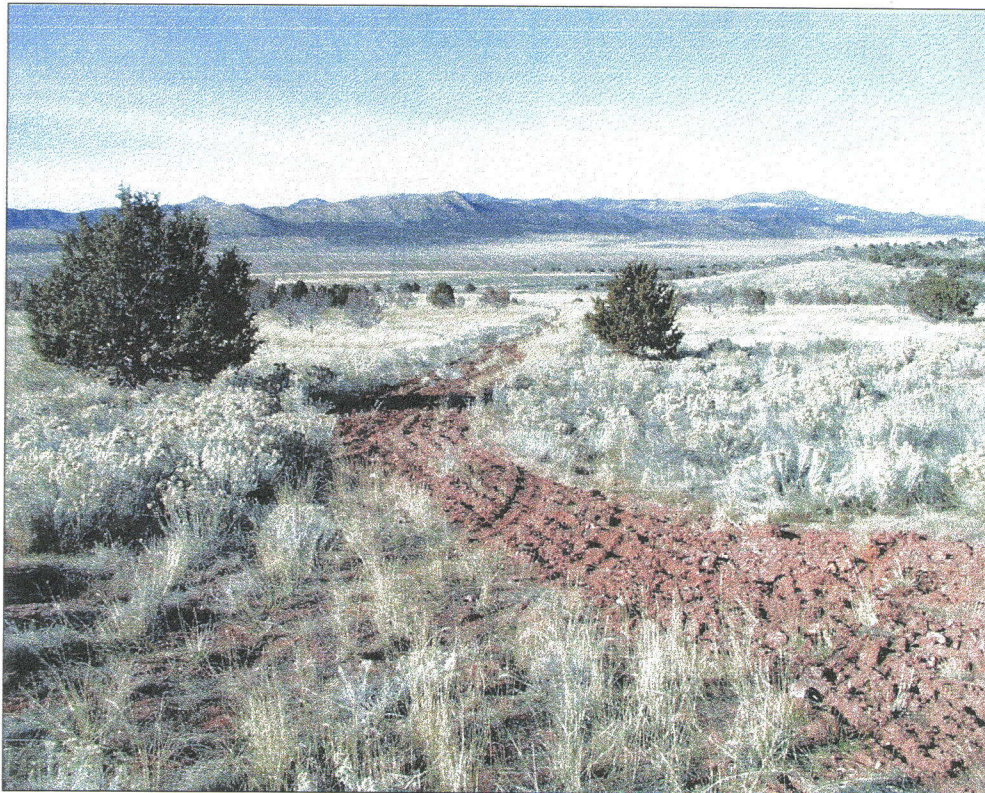
Picture 3: Looking in a Westerly direction at the old road into the quarry. Note the road was ripped and seeded from the BLM fence into the quarry.

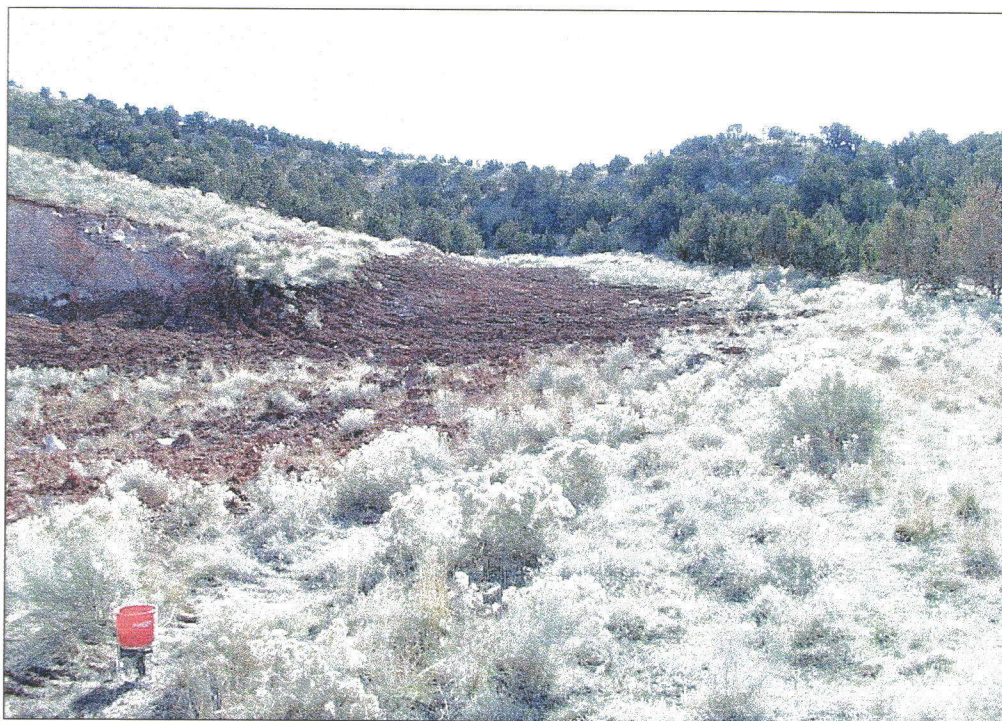
Picture4: Looking in a Southerly direction. Note the area were material was utilized to fill in the area below the south highwall in order to make the highwall safer. Note area was ripped and seeded.

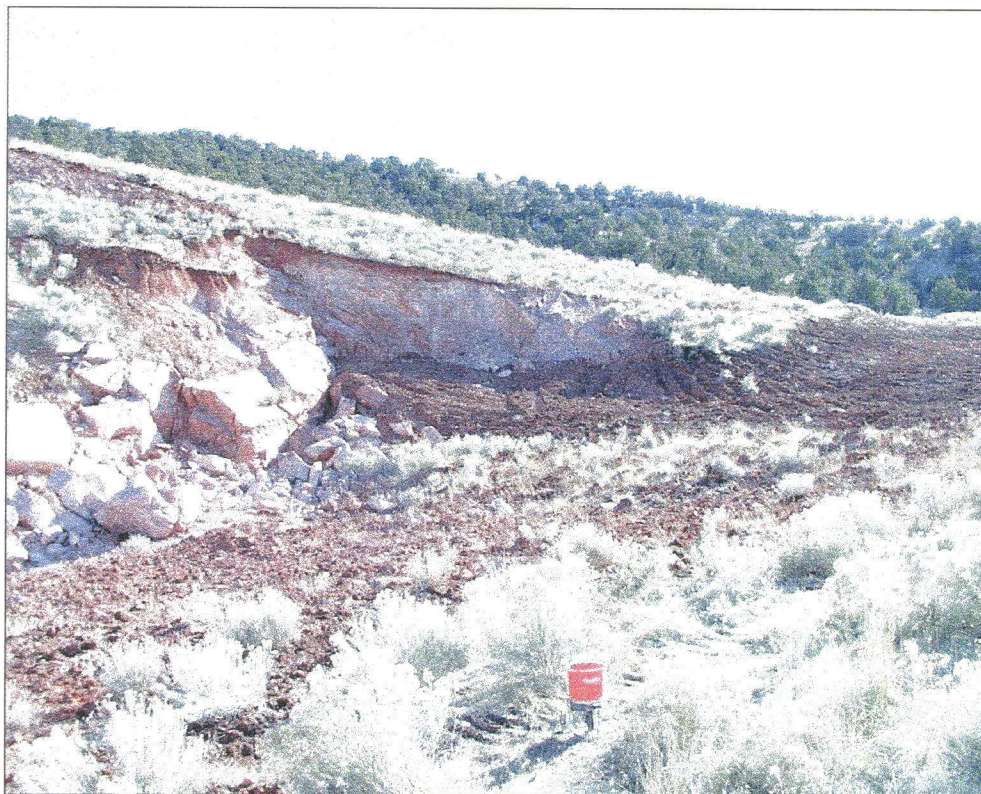
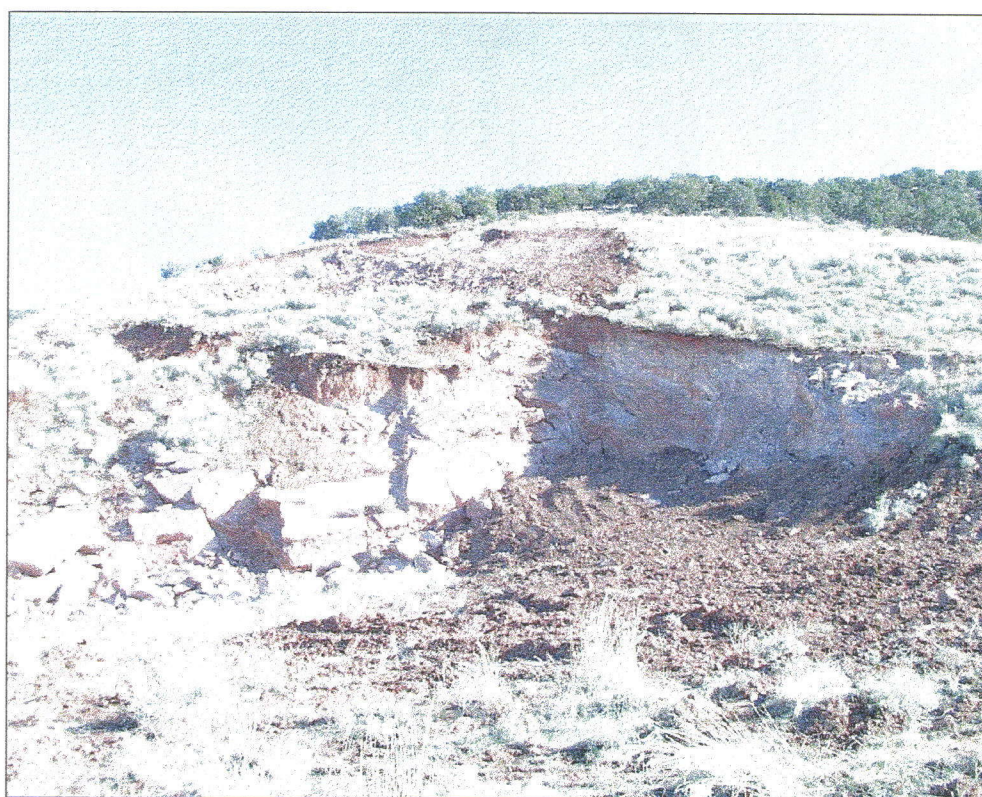
Pictures 5&6: Looking at South Highwall where rocks and soil were pushed up against base to minimize height and make area safer. Area was seeded all the way up to the rock highwall.

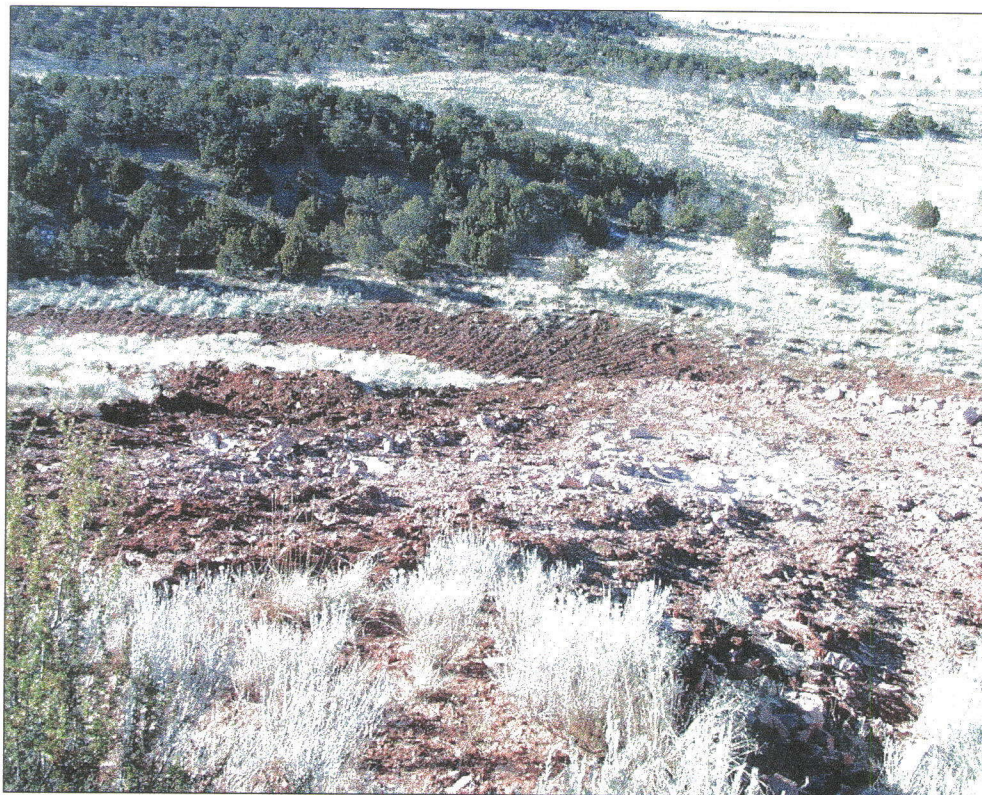
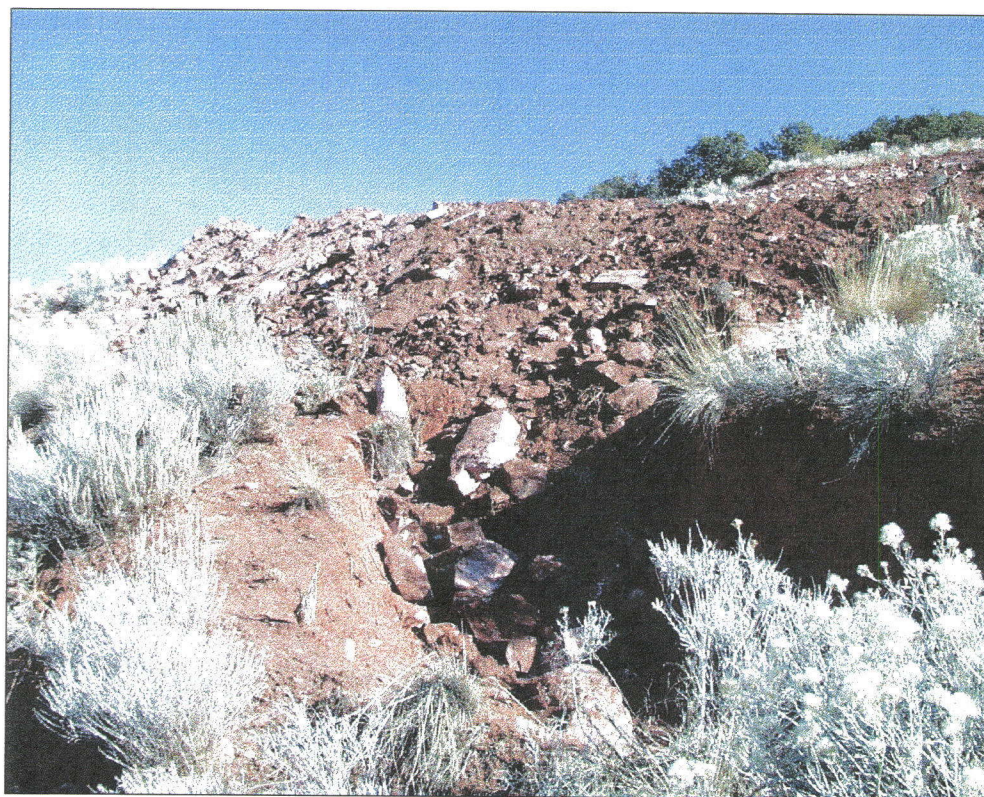
Pictures 7&8: Picture shows how large voids and cracks were filled with material pushed in from above. All newly disturbed areas were ripped where possible and seeded.

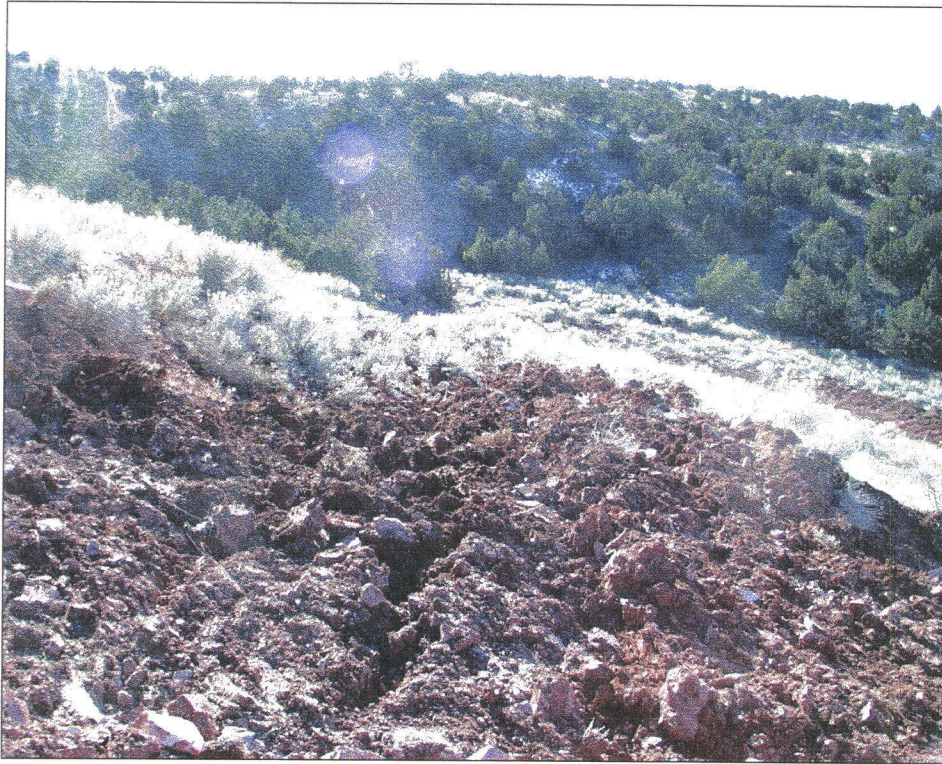
Picture 9: Looking at road that accessed upper quarry benches. Note new contour of edges of road (material was pushed into cracks below). Also, road was ripped and seeded.
